Our tools are designed for a very long usability. To avoid possible errors when changing the 3 AG5 button cells here is our additional note:

**Please double check the correct installation direction (see manual / pictures / tool grip sticker).
Unfortunately some customer do not used the battery-pack tube again after chancing the batteries.
(It is important to use the isolation sleeve.)**

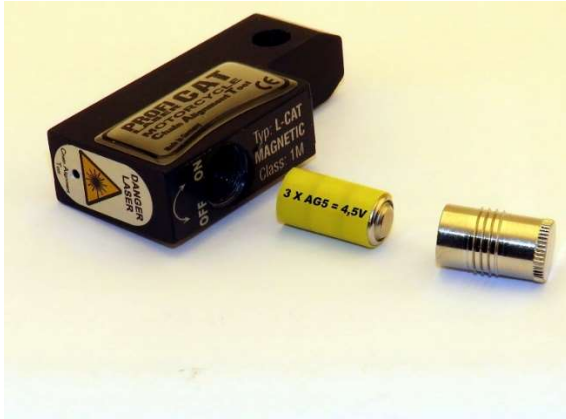
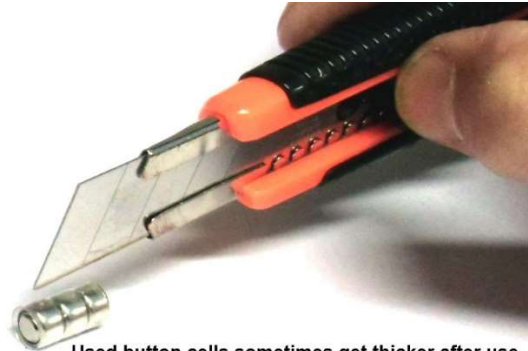
Used button cells sometimes get thicker after use. Slit the insulation and then put in 3 new batteries.

If you maybe don't have the plastic tube any more, please us a simple piece of paper (24 mm x 14mm) and create a new roll into the battery metal screw. Now the button cells are isolated again.

**If the insulating sleeve needs to be replaced or has been discarded:
A simple piece of paper or thin foil can do the same function!**

24 mm X 14 mm
